Case Study 2

PCP Soil, Harbourside Quay Development South Australia

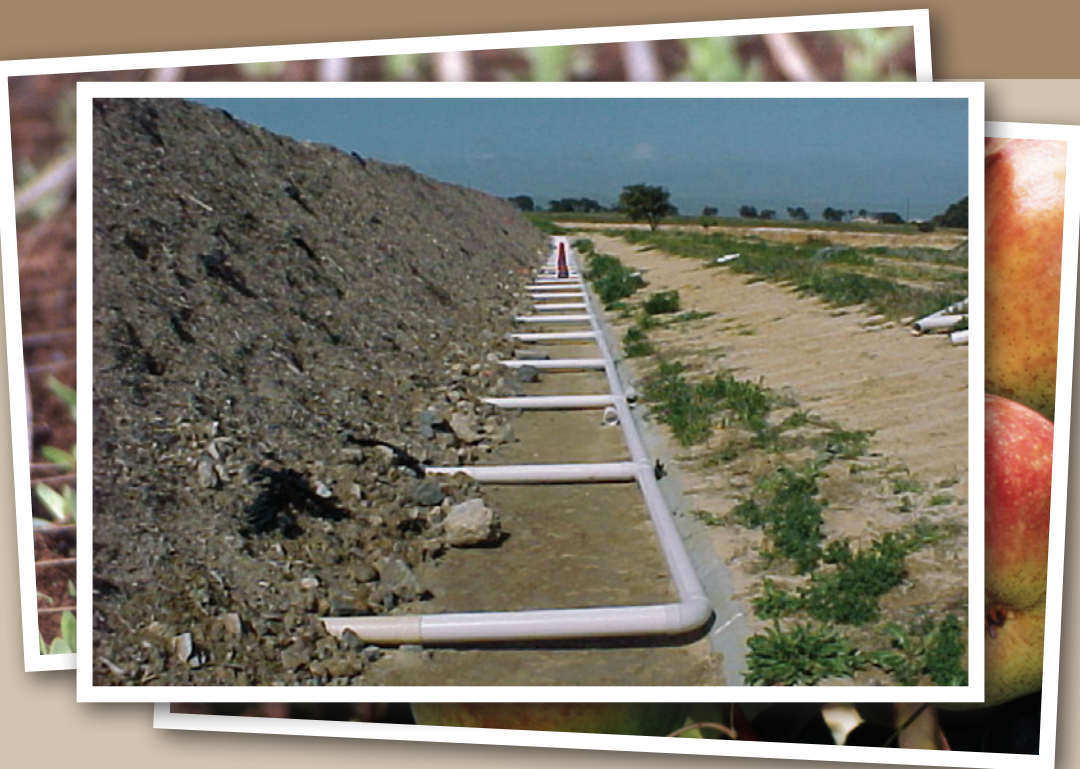
PCP contaminated soil being treated with green organics and sludge. Note the pipe network to facilitate adequate aeration.

- The contaminated soil was mixed with approximately 0.8 volumes of freshly shredded green organics supplemented with 0.2 volumes of abattoir lagoon sludge as additional nutrient source;

- The compost mixture was formed into a single windrow (dimensions approx. 80m length x 8m base width x 4m height in a trapezoid shape) on a network of aeration pipes and pumps embedded in a woodchip base;

- The exhaust air from the vacuum pump was channelled through a large compost/woodchip biofilter to remove volatile hydrocarbons being stripped from the pile;
